Loss of containers overboard from MSC ZOE

1-2 January 2019

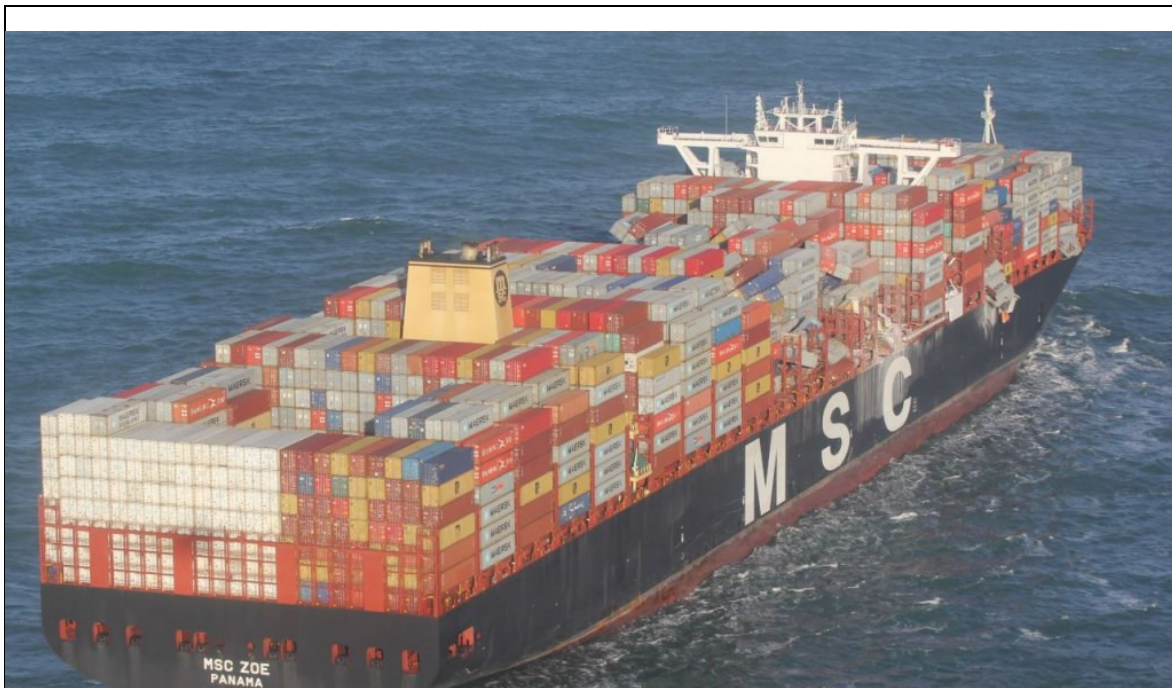
When day broke, the crew started to gain a clearer picture of the situation on deck (see figures 2 and 3). The chief and second officer went in search of the hazardous substances containers and the boatswain was joined by five crew members in retightening the loose lashings. The chief and second officer identified that two of the three hazardous substances containers were missing. The third container was hanging half over the starboard side of the vessel. The crew stated that during their tours of the deck, they found various loose parts of the lashings, including the tensioners from the lashing rods, hooks and locking pins, and twistlocks that were broken in two.

Figure 2: Side view MSC ZOE. (Source: Netherlands Coastguard)

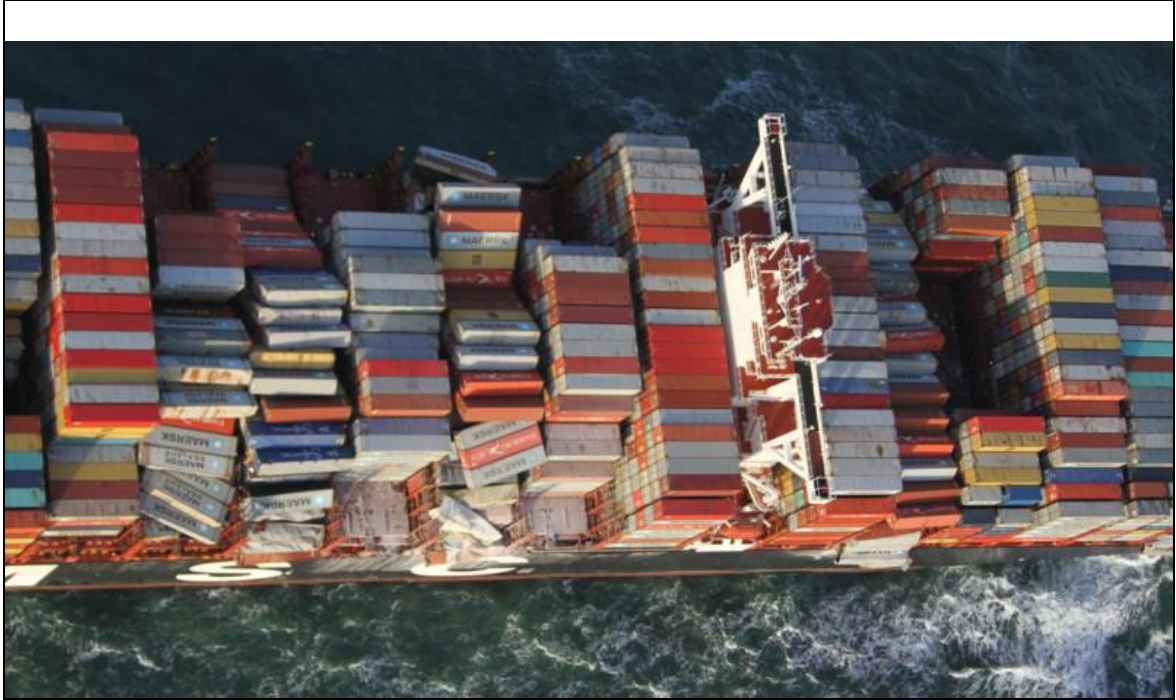
Figure 3: Top view MSC ZOE following the loss overboard of the containers. (Source: Netherlands Coastguard)

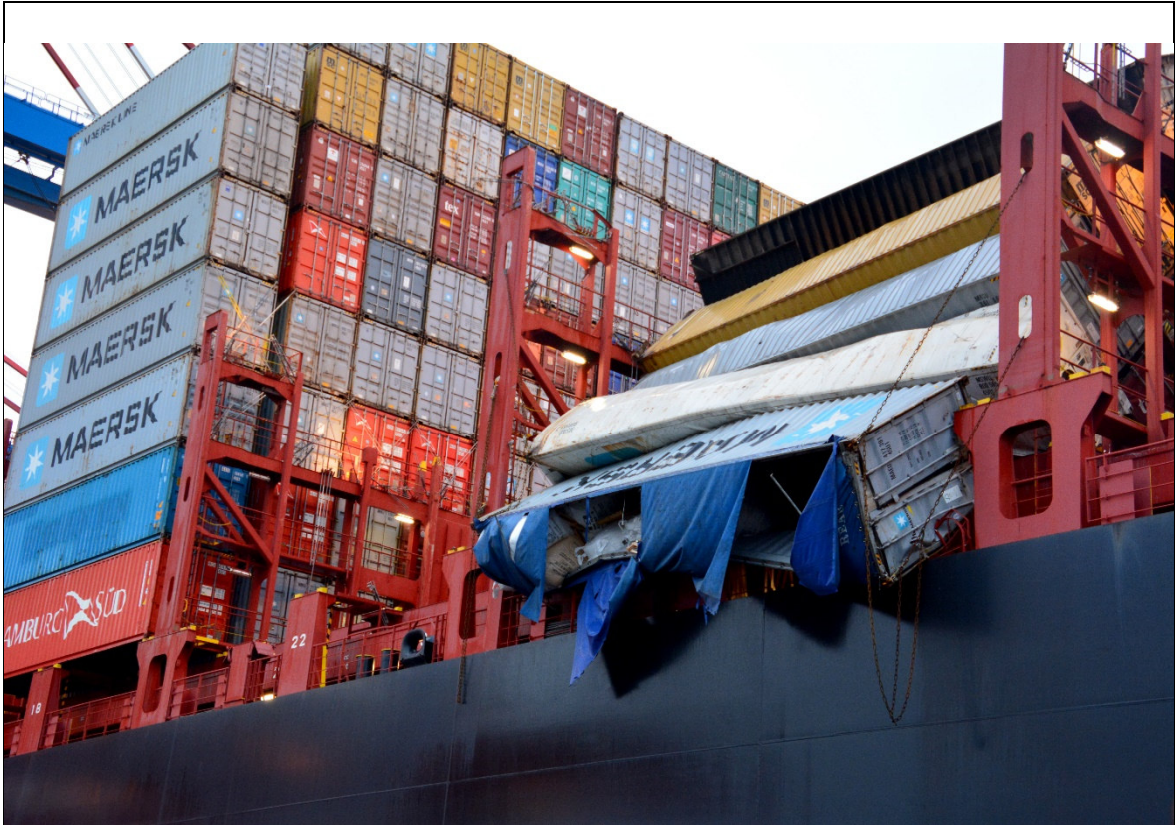
Figure 5: Container with bags with polystyrene balls hanging over the side. (Source: DSB)

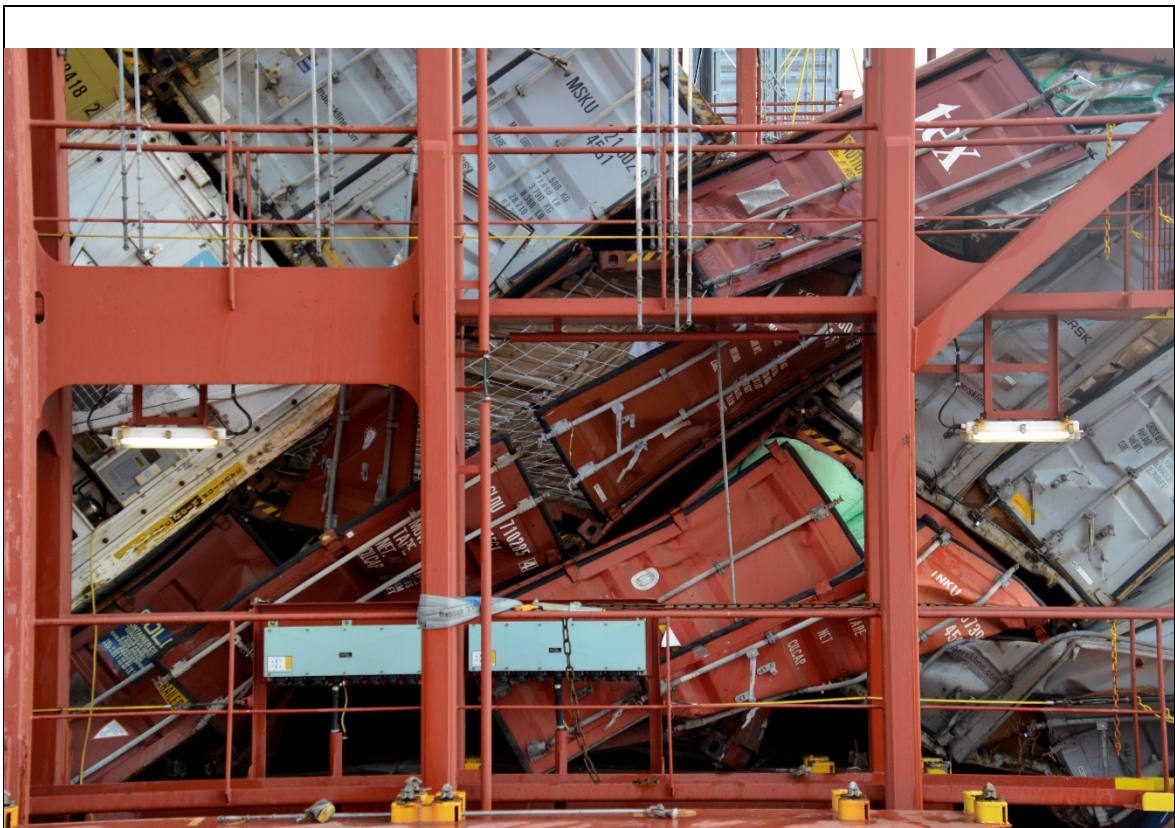
Figure 6: Crushed containers on board MSC ZOE. (Source: DSB)

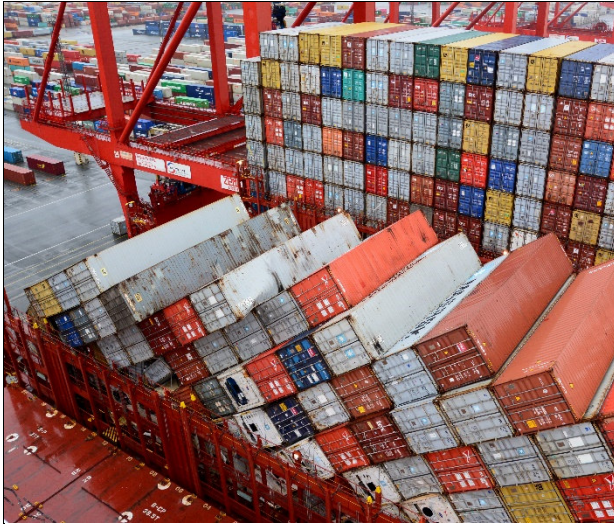
Figure 7: View on bay 26 (Source: DSB)

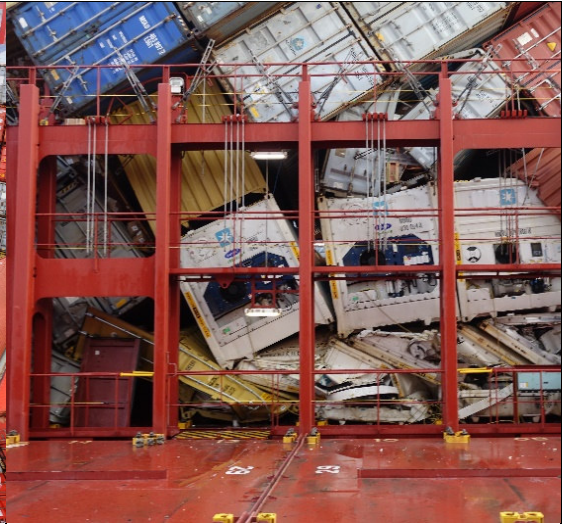
Figure 8: Collapsed containers in bay 26. (Source: BSU)

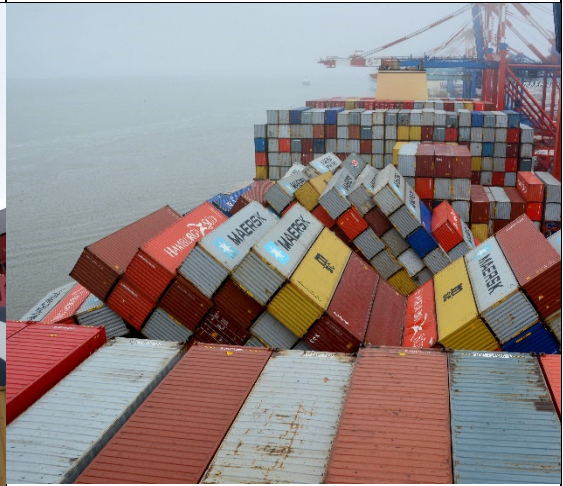
Figure 10: View on bay 42, 50 and 54 (Source: DSB)

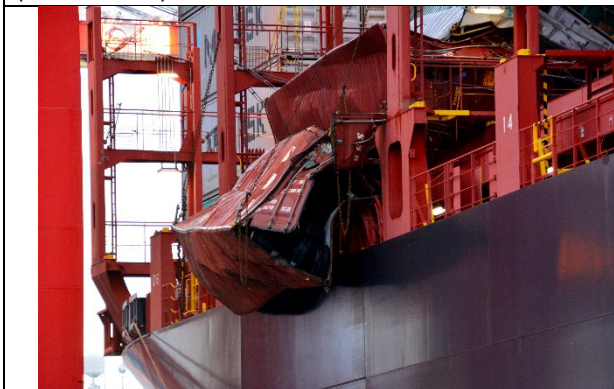
Figure 11: View on bay 10, port side. (Source: DSB)

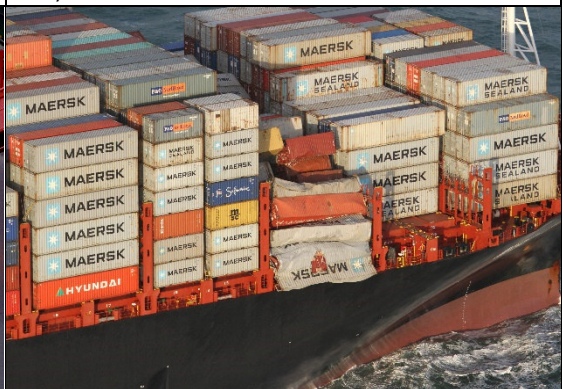
Figure 12: View on bay 10, starboard side. (Source: Netherlands Coastguard)

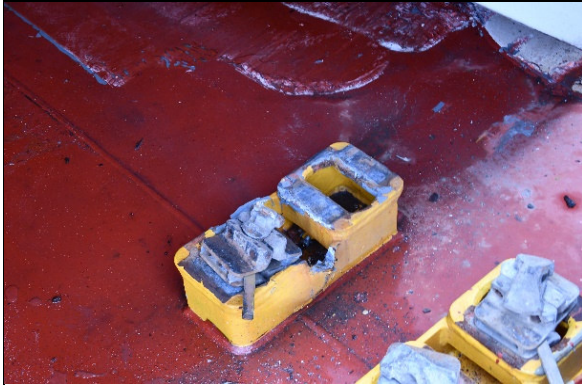
Figure 15: Broken twistlock in a bent deck fitting (Source: German Waterway Police)

Figures 13 to 18 show evidences of the damages to lashing material and deck fittings. Some container stacks remained, even on their side, securely fastened to each other with twistlocks. In the bays with damaged or lost containers, broken twistlocks were found. Also bent or deformed lashing rods and turnbuckles were found, as well as broken mounts from the lashing bridges with the turnbuckle still attached.

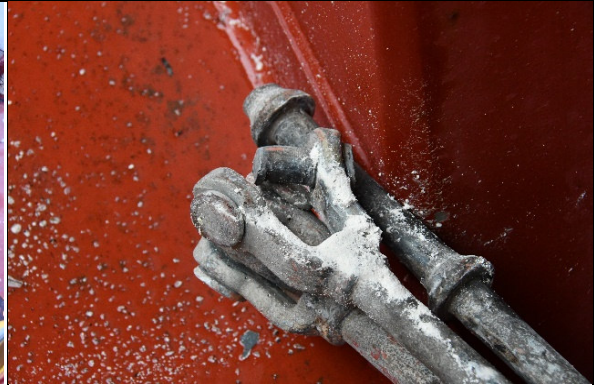
Figure 16: Broken turnbuckle (Source: German Waterway Police)

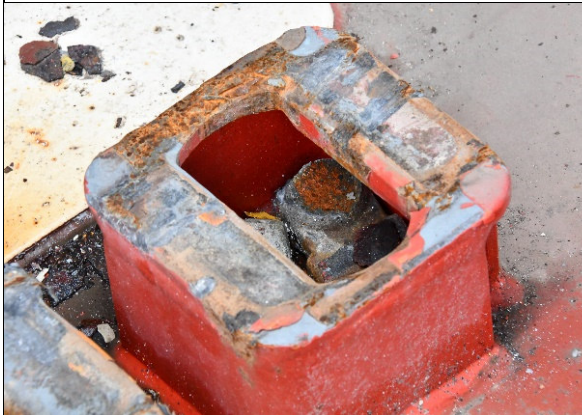
Figure 17: Broken twistlock in deck fitting (Source: German Waterway Police)

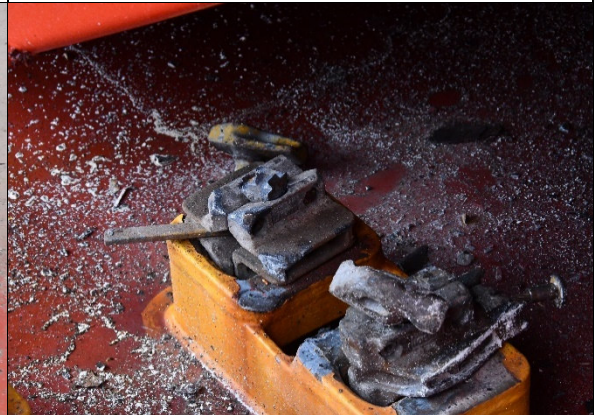
Figure 18: Broken twistlock (Source: German Waterway Police)

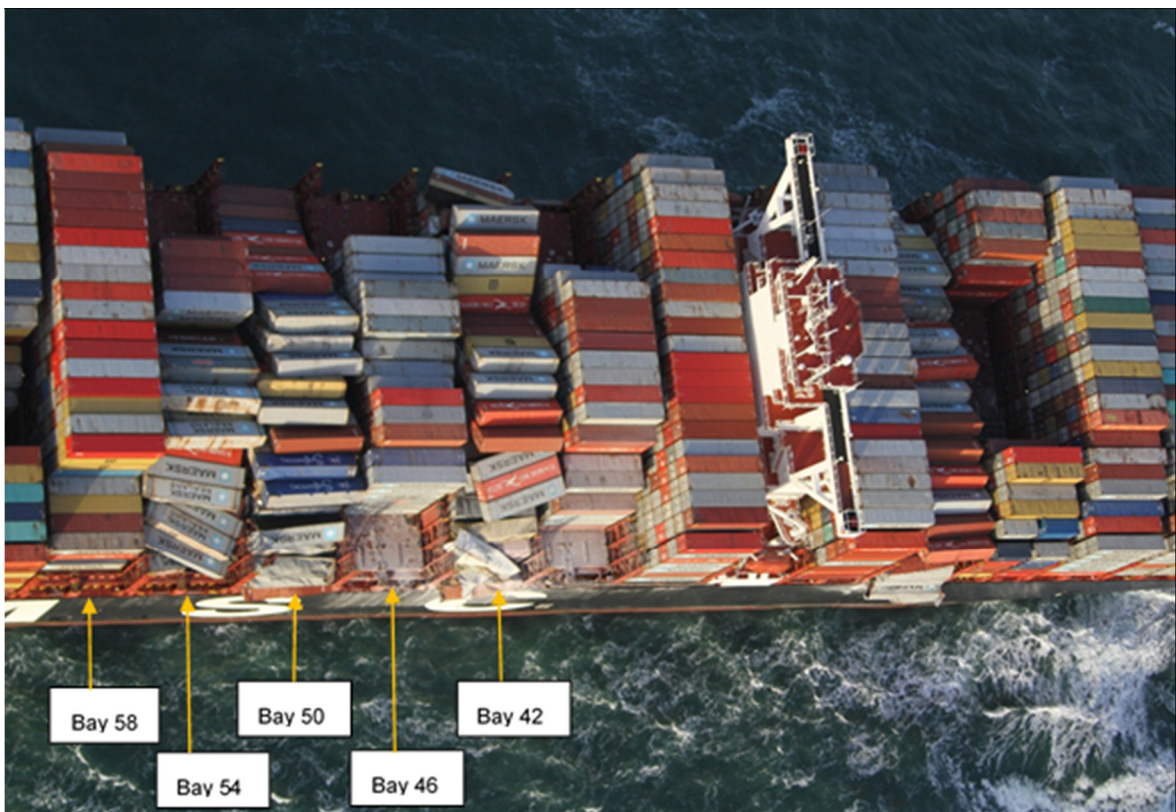
Figure 25: Top view of the bays with lost containers. (Source: The Netherlands Coast guard)

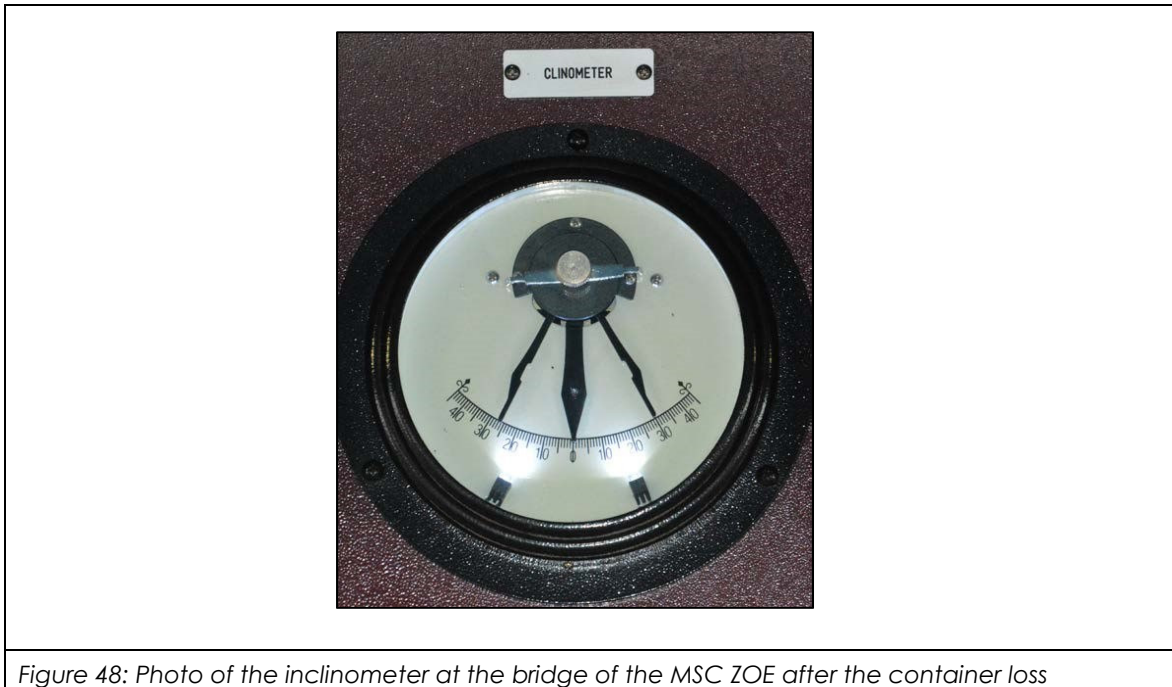
Figure 48: Photo of the inclinometer at the bridge of the MSC ZOE after the container loss
