Loss of containers overboard from MSC ZOE

1-2 January 2019

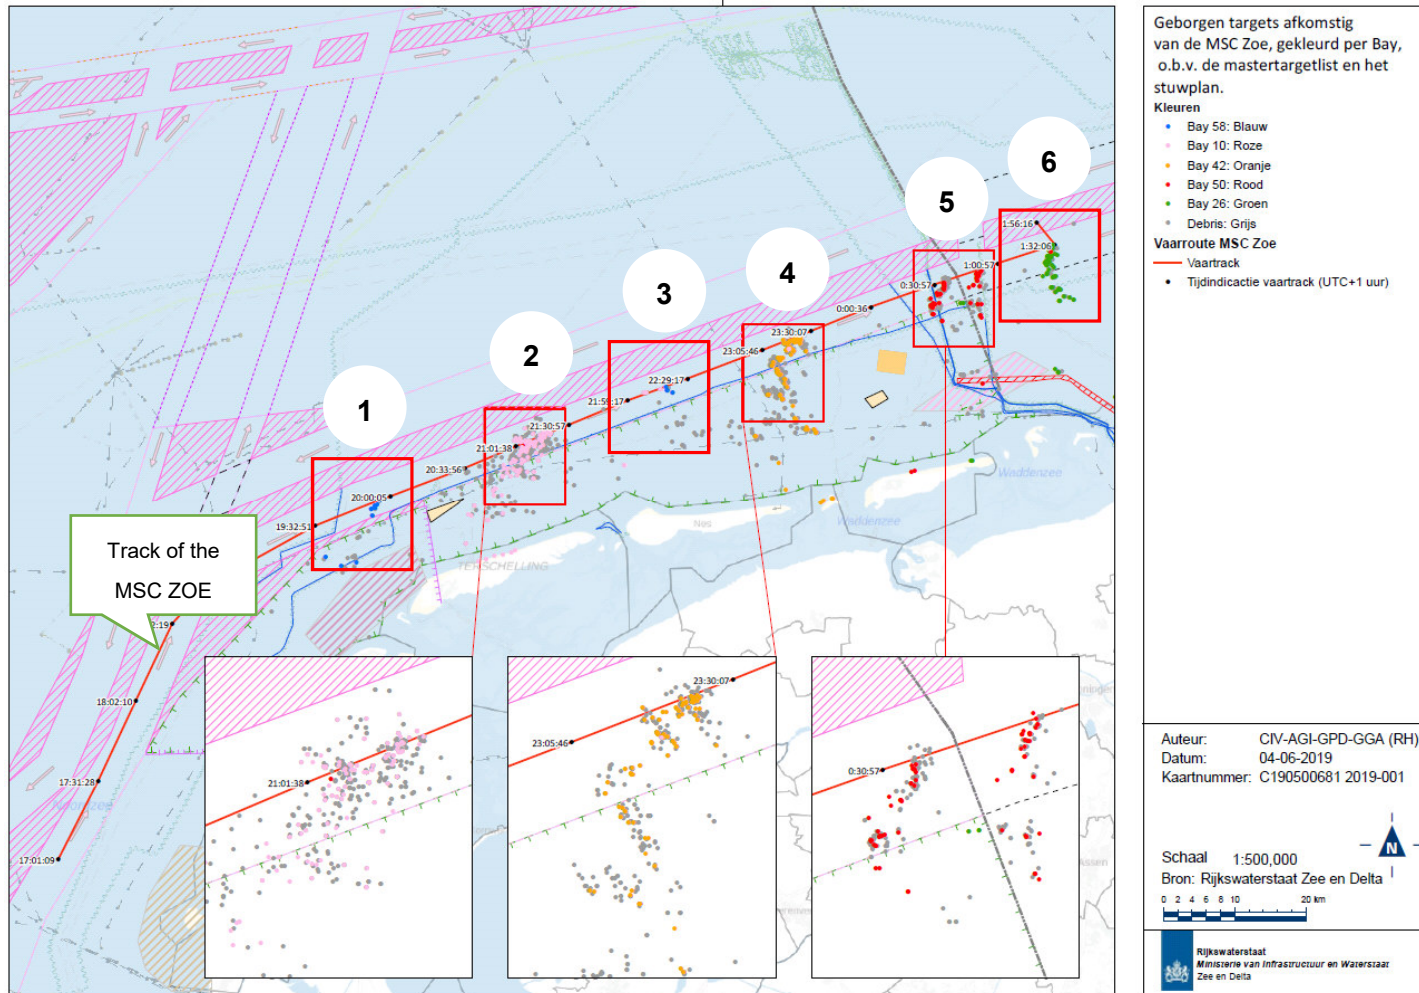
Figure 20. Recovery locations of lost containers. Six main locations can be identified. Colours indicate bay number on board the ship: blue=bay58, pink=bay10, orange=bay42, red=bay50, green=bay26, grey=debris. Track of the MSC ZOE is indicate in red. (Source: Rijkswaterstaat, the six locations added by the investigation team)

Figure 20 shows that large numbers of containers were recovered at six locations. Combining this with the sailing route of the MSC ZOE, it was possible to reconstruct where and when which containers fell overboard. The MSC ZOE lost containers from the bays 10 (9/11) (pink), 26 (green), 42 (orange), 50 (red) and 58 (blue). Bays 46 and 54 also contained damaged containers, but they didn't fall overboard (see chapter 4).

The first containers were lost shortly before 20.00 hours (blue dots in figure 20). At that time, the MSC ZOE was located to the north of the most easterly point of Vlieland. These containers originated from bay 58, in the middle of the ship (see figure 21). The most notable element of this initial loss moment was that all the containers fell over the starboard side (see figure 22).

The second loss of containers occurred between 21.05 and 21.20 hours (pink dots in figure 20). At that time the MSC ZOE was located to the north of Terschelling. These containers originated from bay 10 at the bow of the vessel (see figure 21). Approximately the same number of containers fell overboard from both sides of the vessel (see figure 22).

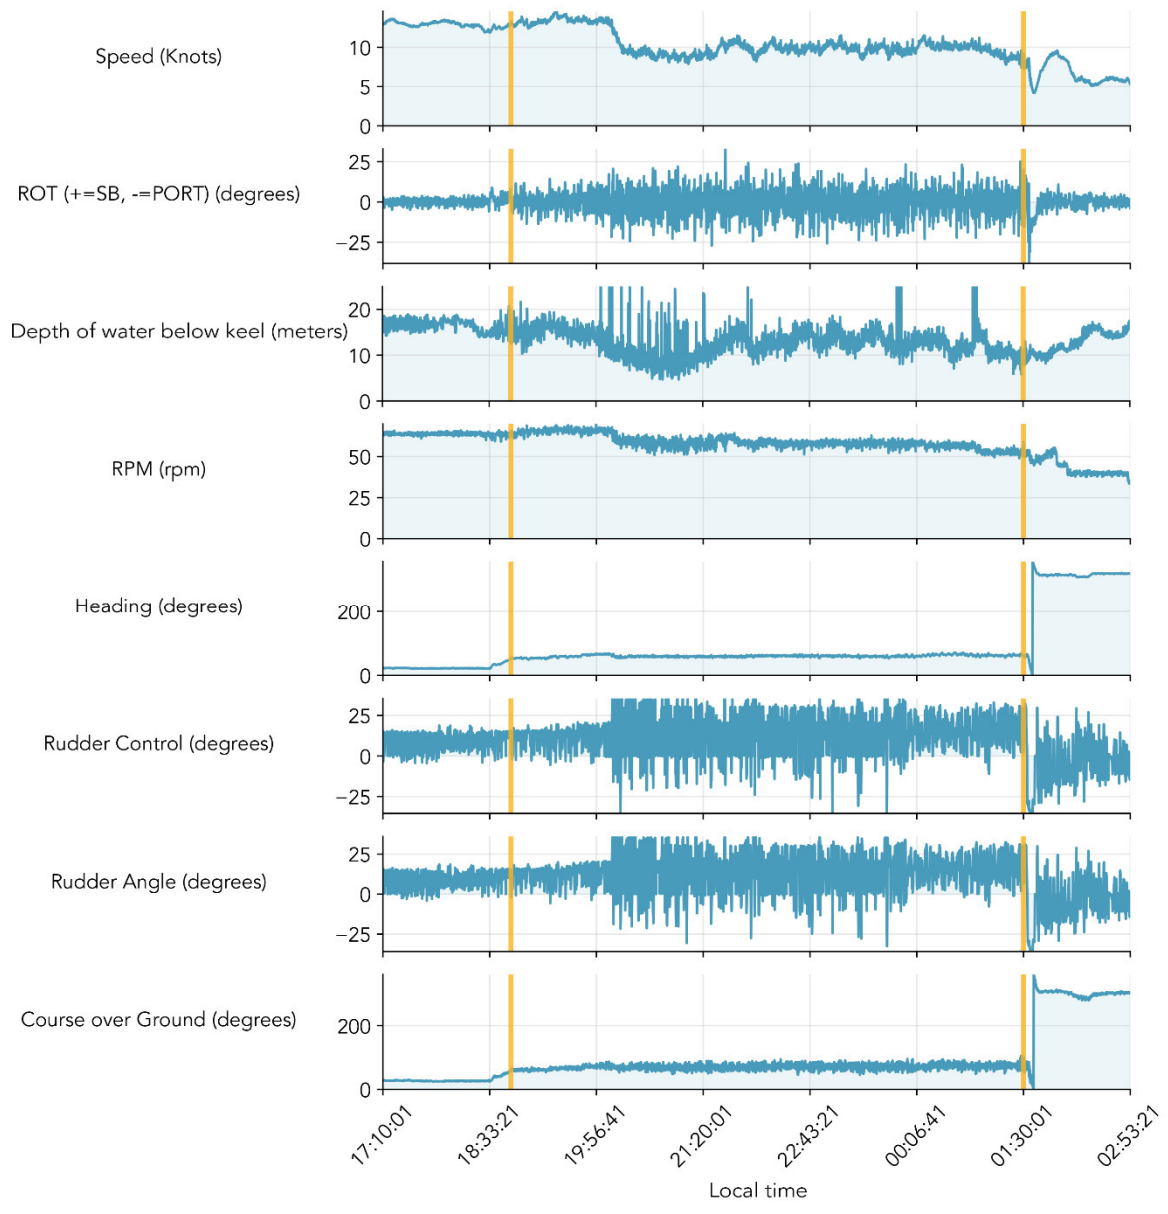
Some noise can be reduced through software, but this is not always possible. In figure 23 the measurement of the echo sounder is shown. It also shows several peaks at 50 or even 100 meters. These are considered noise, since such water depths are not present at that location of the MSC ZOE. Because these peaks start to show up during the time where the roll motion is also increased, it is likely noise (outliers) caused by the roll of the ship or due to the ship's noise which is increased during this part of the voyage.

Figure 23: Selected parameters from the Voyage Data recorder (VDR) in local time.

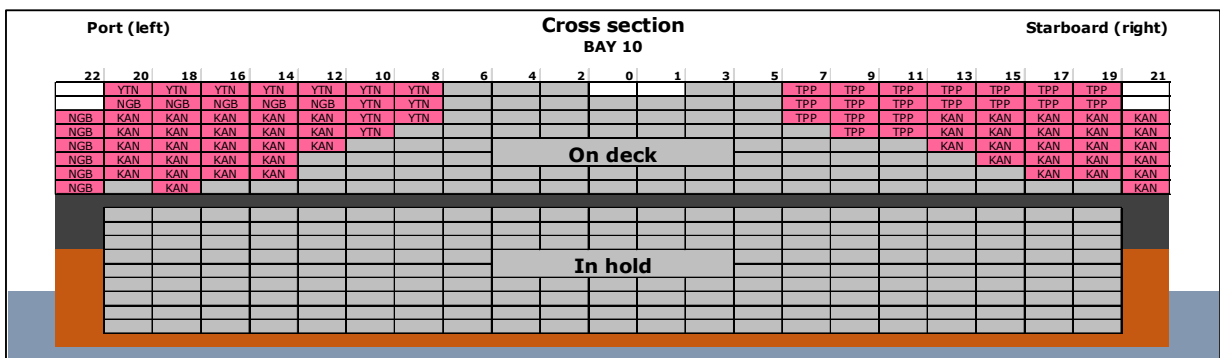
The containers lost from bay 10²⁴ were loaded in all Asian ports except Xinyang and Shanghai and were destined for Gdansk.

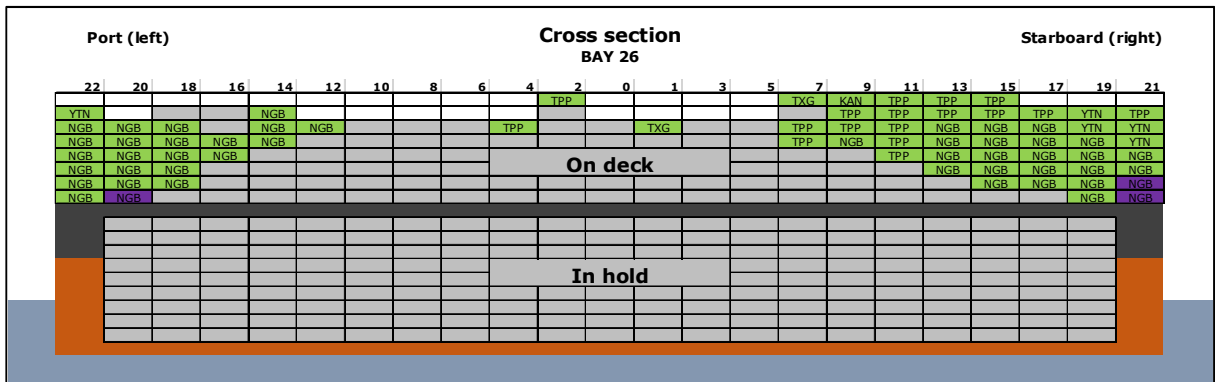
The containers lost from bay 26 were loaded in all Asian ports except Shanghai and destined for Gdansk. Bay 26 contained 3 containers with dangerous goods, coloured purple. The two containers on starboard were lost; the one on port side remained on board but lost some of its content.

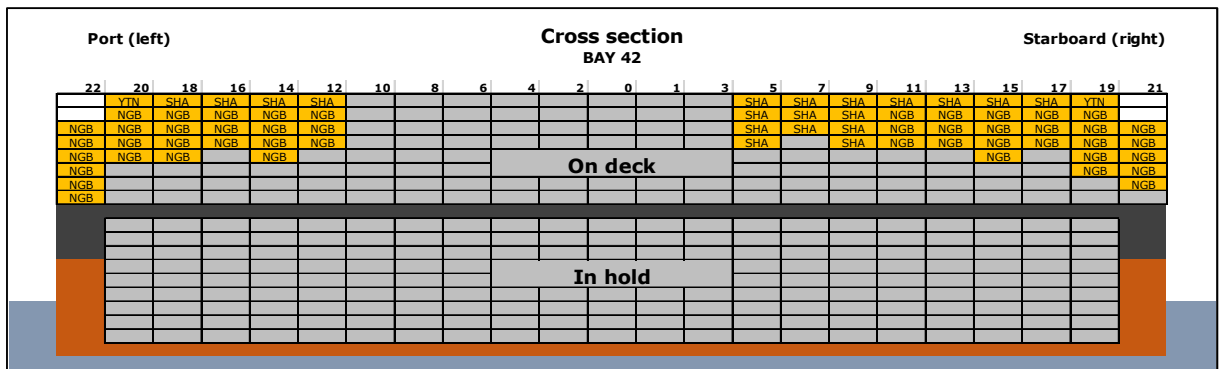
The containers lost from bay 42 were loaded in Ningbo, Shanghai and Yantian and were destined for Gdansk.

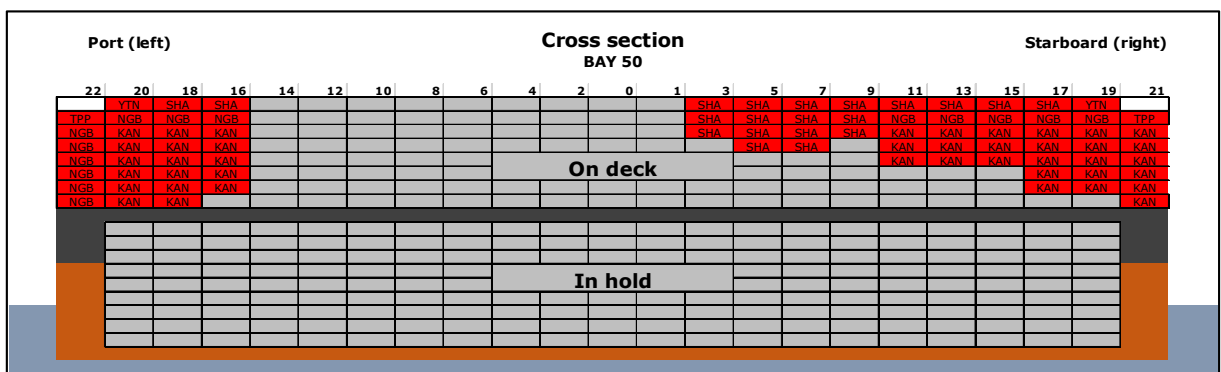
The containers lost from bay 50 were loaded in all Asian ports except Gwangyang and Shanghai and were destined for Gdansk.

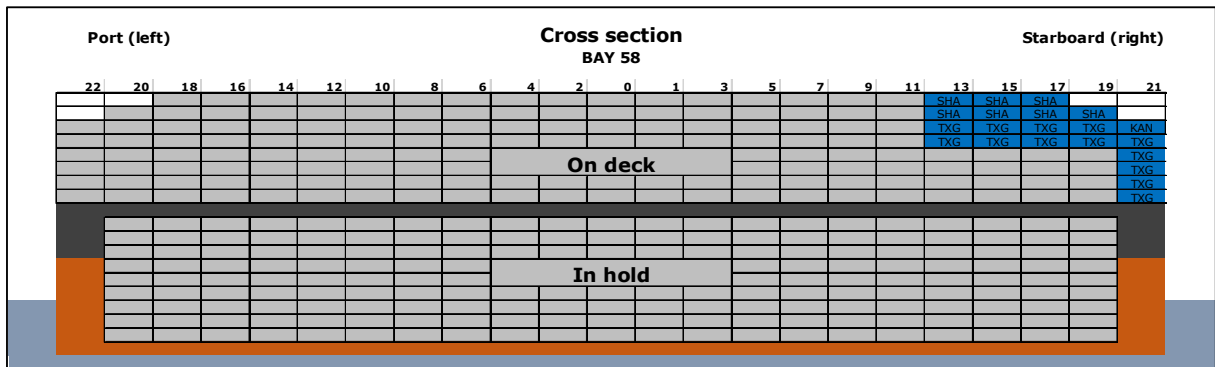
The containers lost from bay 58 were loaded in Xinyang, Gwanyang and Shanghai and destined for Gdansk.

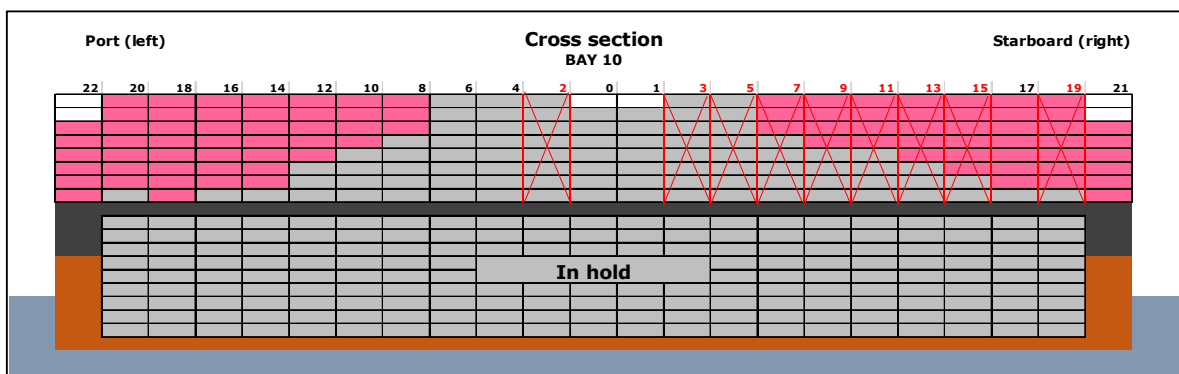
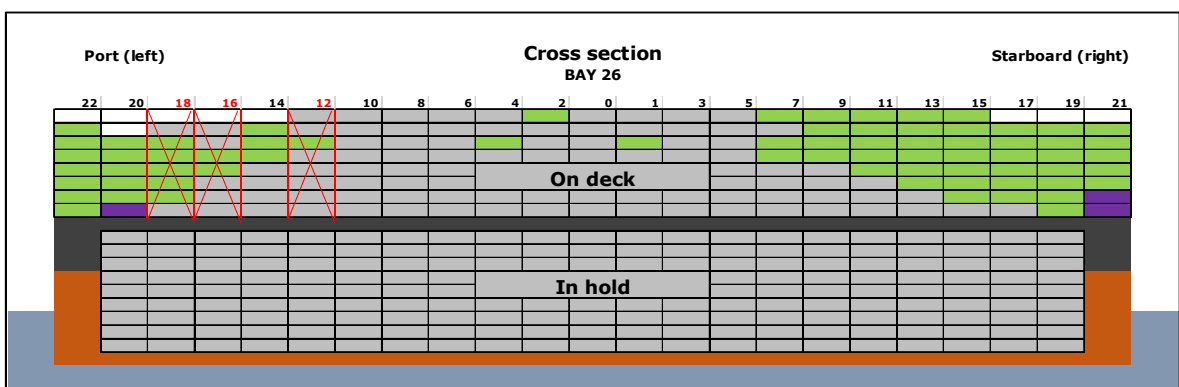
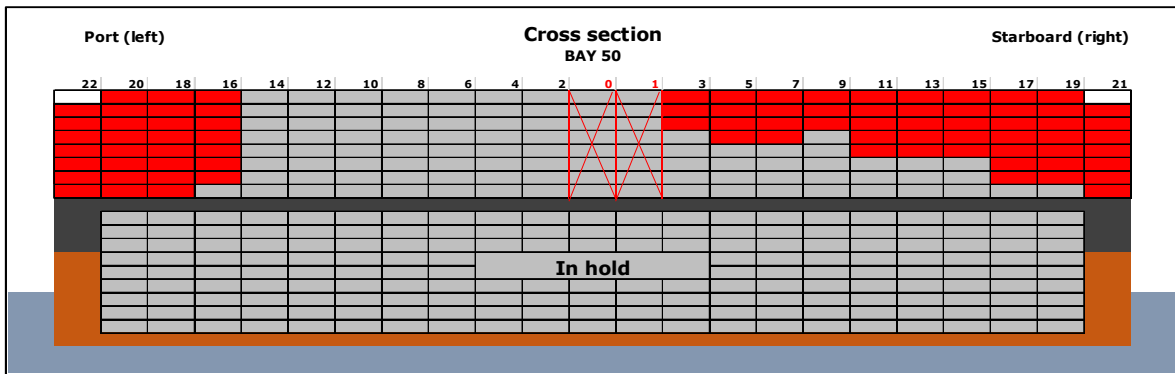
During the on-site investigation in Bremerhaven the loading computer on board the MSC ZOE indicated, for the accident voyage, red warning boxes in bays 10 (9/11), 18, 26, 30, 50, 62 and 70. A red warning box indicates an exceedance of any of the tolerance limit of one of the six possible reasons listed above. The exceedance of the tolerance limits where, however, not further specified. From bay 10 (9/11), 26 and 50, which showed red warning boxes based on the information retrieved in Bremerhaven, containers fell overboard. But bays 42 and 58, where containers also have been lost, did not have any red warning boxes.

Despite the preparation for the voyage from Sines to Bremerhaven, the loading computer on board the MSC ZOE indicated red warning boxes in bays 10 (9/11), 18, 26, 30, 50, 62 and 70. During the safety investigation, it was not possible to determine which limits had been exceeded. In the lashing software of the loading computer the applicable service area can be selected by a tick box (eg *Asia-Europe*). Depending on the area of operation, parameters used for the calculations may differ. MSC provided a simulation with the lashing software based on the loading condition of the accident voyage. The simulation showed a clear difference when ticking the box *Unrestricted service* or *Asia-Europe* in the service area menu. However, the displayed values as seen during the on-site investigation could not be reproduced afterwards, because it was not feasible to retrieve all used settings. MSC states that changing a few tick boxes in the computer may change all the calculations and this could have happened on board the MSC ZOE, since many people had been working on the computer, before the investigators were shown the data in Bremerhaven.

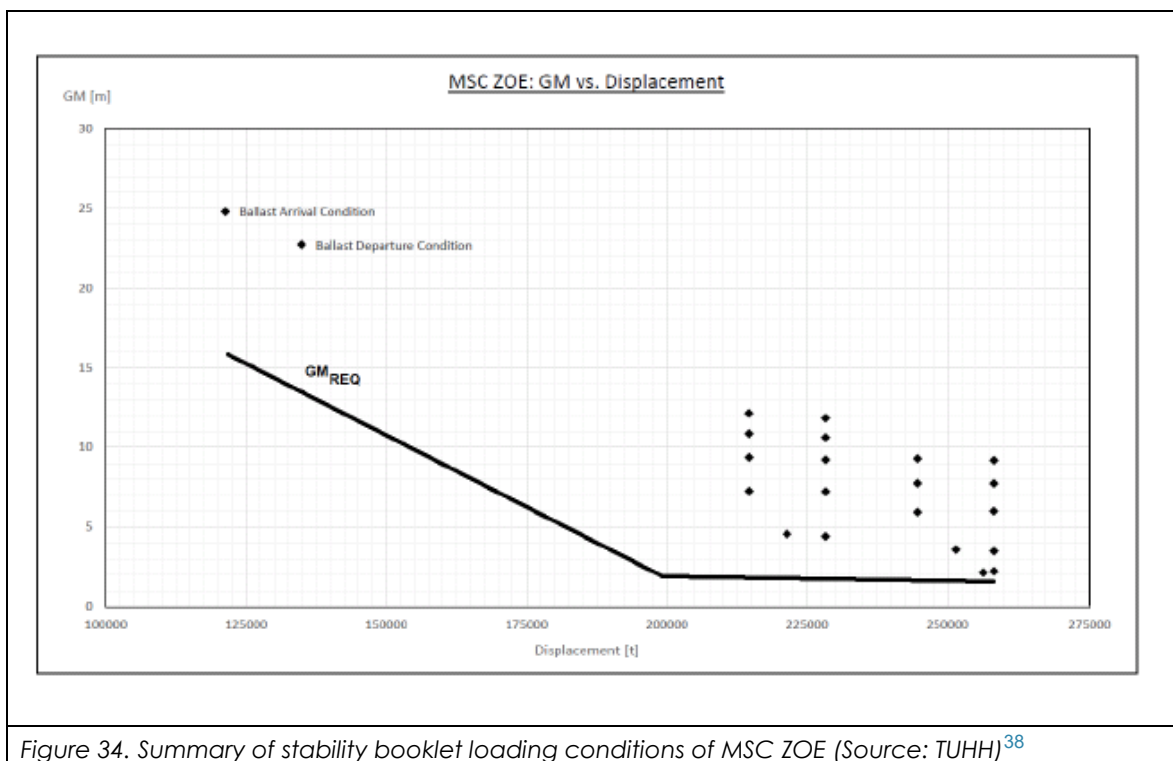
The sample conditions in the CSM are based on a GM of ≤ 2.08 m, the loading computer on board should be used for any different GM to make the corresponding calculations. The MSC ZOE sailed with a solid³⁷ GM of 10.23 m which was corrected for (partly) filled tanks, the so-called free surface correction. The corrected GM of 9.01 m was used in the loading computer. Thus the MSC ZOE sailed with a high stability.

The table from the stability booklet confirms that although a solid GM of 10.23 is considered a high value, this was not an unusual condition for the MSC ZOE (see figure 34).

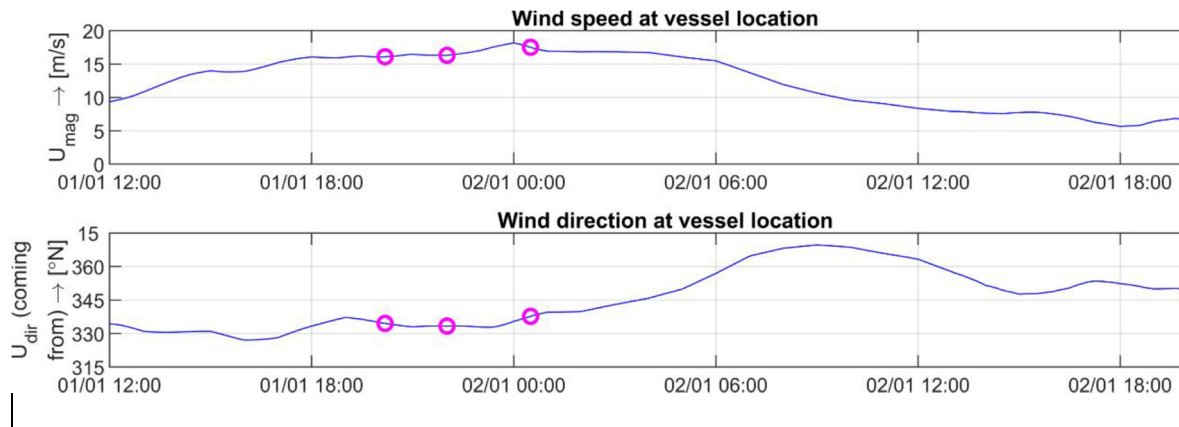
Figure 37: Modelled wind speed and wind direction along the route of MSC ZOE.

Modelled wind speed and wind direction along the route of the MSC ZOE are depicted in figure 37. On January 1, the wind direction changed gradually from west to north-northwest. The wind speed increased during the day. At the time of the peak of the storm (around 01.00 hours LT on January 2), the MSC ZOE passed north of Schiermonnikoog.

The wind speeds encountered by the MSC ZOE in the TSS Terschelling – German Bight were between 16-18 m/s (up to 8 Bft) with gusts of wind force two over the mean. The peak of the storm occurred around 01.00 hours LT on January 2. The wind approached the ship from abeam. The encountered heavy conditions are neither extreme nor exceptional for this part of the North Sea.

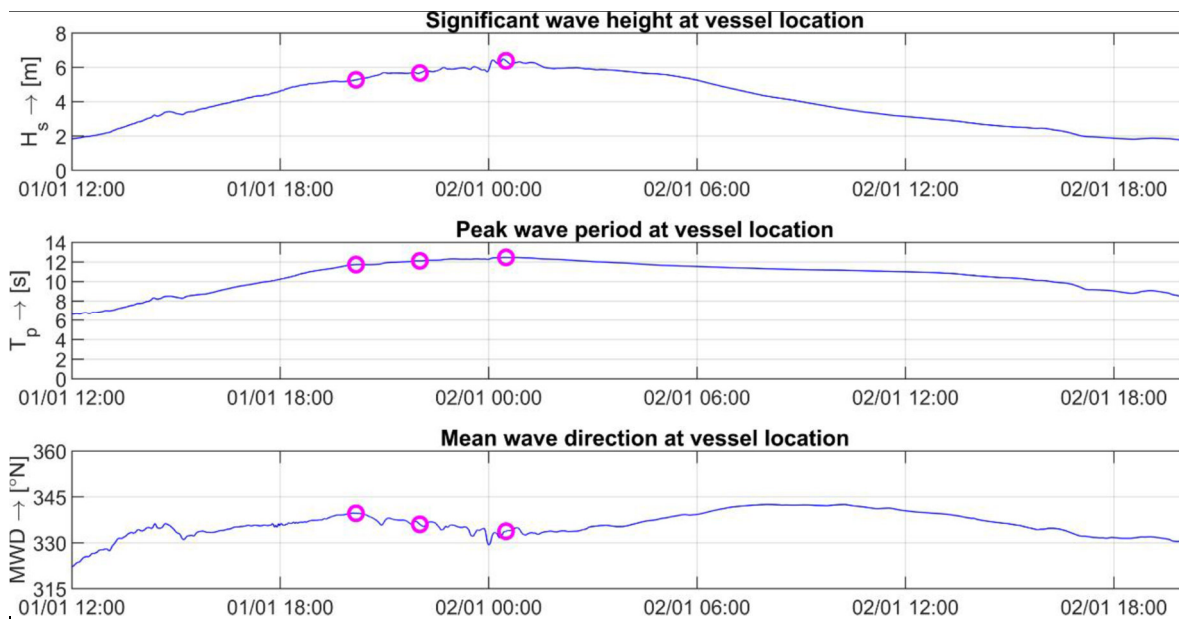
Figure 40: Wave conditions along the route of the MSC ZOE.

Deltares modelled the wave conditions encountered by the MSC ZOE when it was sailing in the TSS Terschelling – German Bight based on, among other sources, information of three wave buoy and five offshore platforms, see figure 40. The wave height that the MSC ZOE encountered developed with the increasing wind speed. On January 1 at around 15.00 hours LT, at the time that the ship was sailing along the Dutch west coast, the significant wave height (H_s) was 2.5 meters. Five hours later, at 20.00 hours, the significant wave height (H_s) was around 5.2 meters. The ship experienced the largest waves with a significant wave height of 6.5 meters at approximately 01.00 hours on January 2, after passing the island of Schiermonnikoog. The peak wave period (T_p) experienced during the moments of container loss (between 20:00 hours and 01:30 hours LT) were between 11.8 and 12.5 seconds.

The waves approached the MSC ZOE from abeam. This wind direction allows the waves to build up as there is a long fetch length available on the North Sea. Significant wave height increased from 5 m to 6.5 m at the peak of the storm. The maximum wave height during this time reached up to around 11 meters. The peak wave period encountered was approximately 11.8 - 12.5 seconds. The wave conditions are neither very extreme nor exceptional for this part of the North Sea.

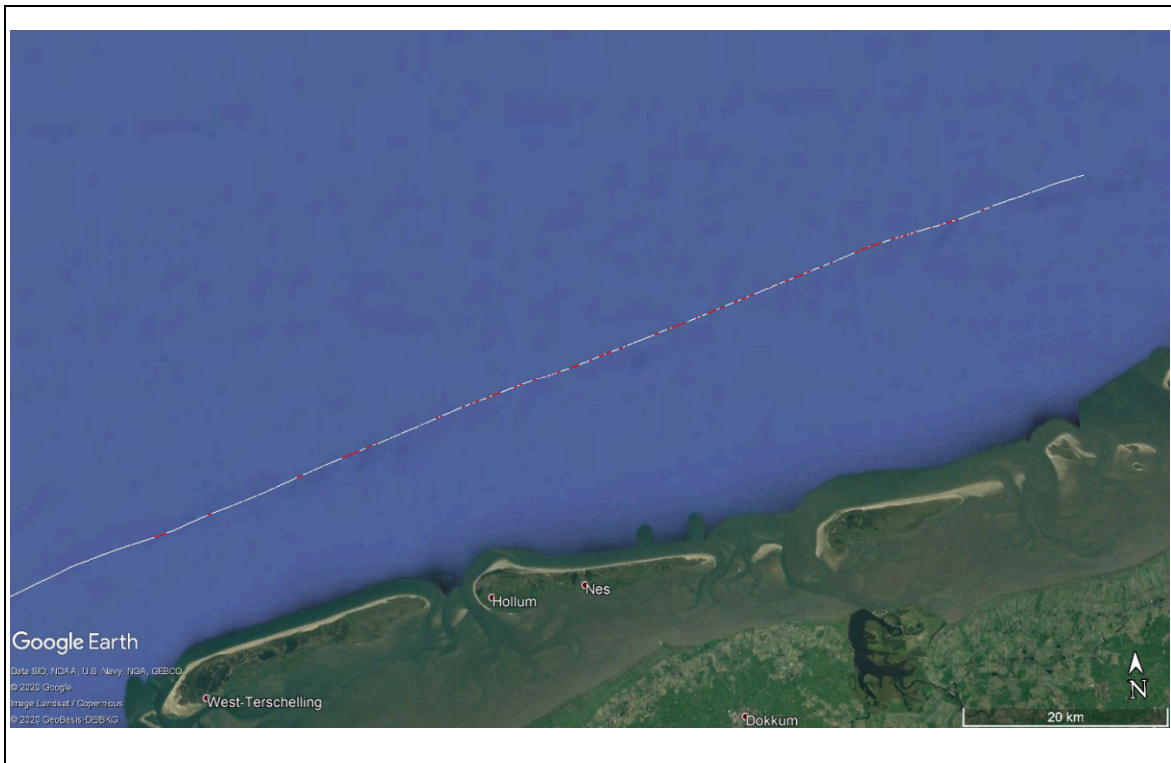
Figure 43: Periods where the rolling motion was intense enough to be detectable by the human ear through shifting objects on the bridge are indicated in red. (Source: Google Earth)

A further analysis of the VDR audio recording was done by the investigators. On the recordings of the microphones on the bridge, at certain intervals a peak in amplitude was noticed, caused by shifting equipment moving back and forth. The assumption was made that movement of the equipment was due to the rolling of the ship to such a degree that objects on the bridge would start to shift. Automated analysis was used to determine the roll period and periods where the rolling was most intense (audible to the human ear).

The mean, median and mode all indicate that a full roll period of the ship was approximately 14.7 seconds. Furthermore, based on the audio analysis, figure 43 was created. More intense rolling periods, where the peaks are audible to the human ear, are indicated in red.

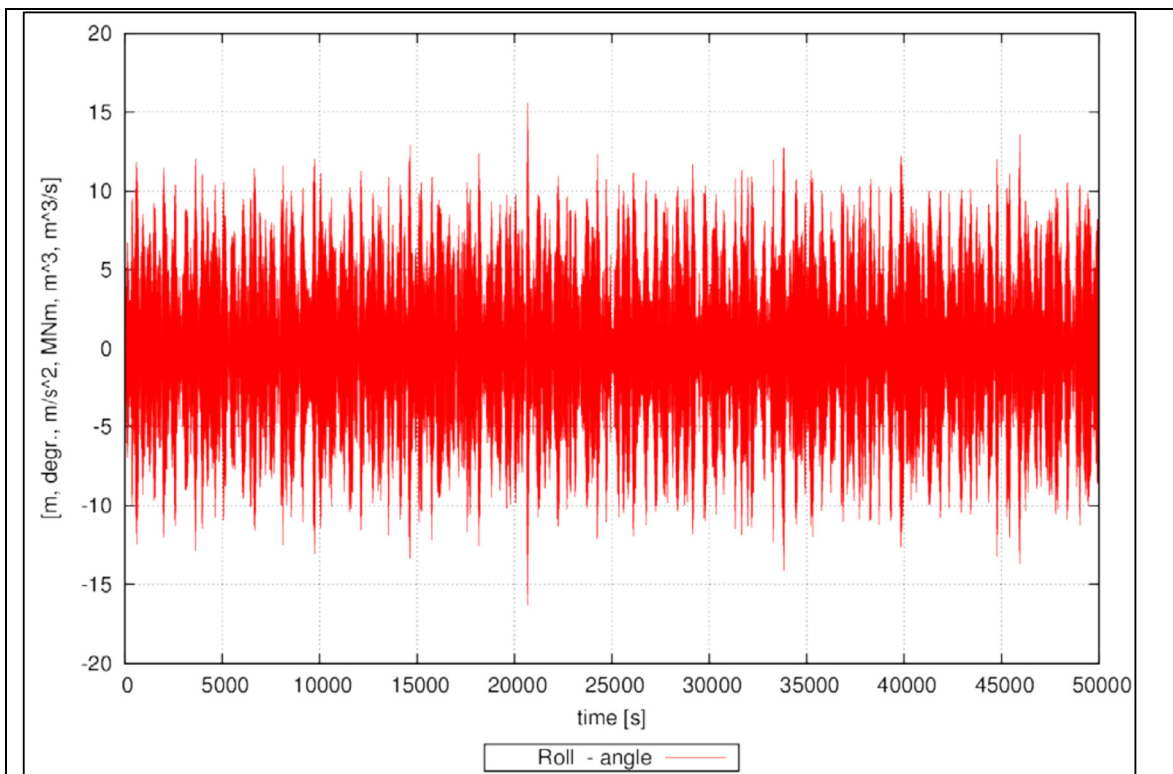
Figure 45: Computed time series of the roll angle of MSC ZOE. Accident condition, speed 10 kn, encounter angle 93°, 50000 s simulation time (Source: TUHH)

The TUHH performed numerical simulations to calculate the roll motions for the MSC ZOE at the time of the accident. The results of the simulation show the vessel permanently rolling with roll amplitudes between 5 and 10°, see figure 45. It also shows that at one time, a roll angle of around 16° occurs. According to TUHH, this roll angle may be the result of a group of larger waves hitting the ship.

Calculations by the TUHH of the effect of the beam wind on the roll motion indicate that the effect is limited. As the stability of the ship is very high, the wind force will not lead to a significant increase of the roll angle. The calculation including the wind heeling moment showed an increase of the maximum roll from 16.3° to 16.9°.

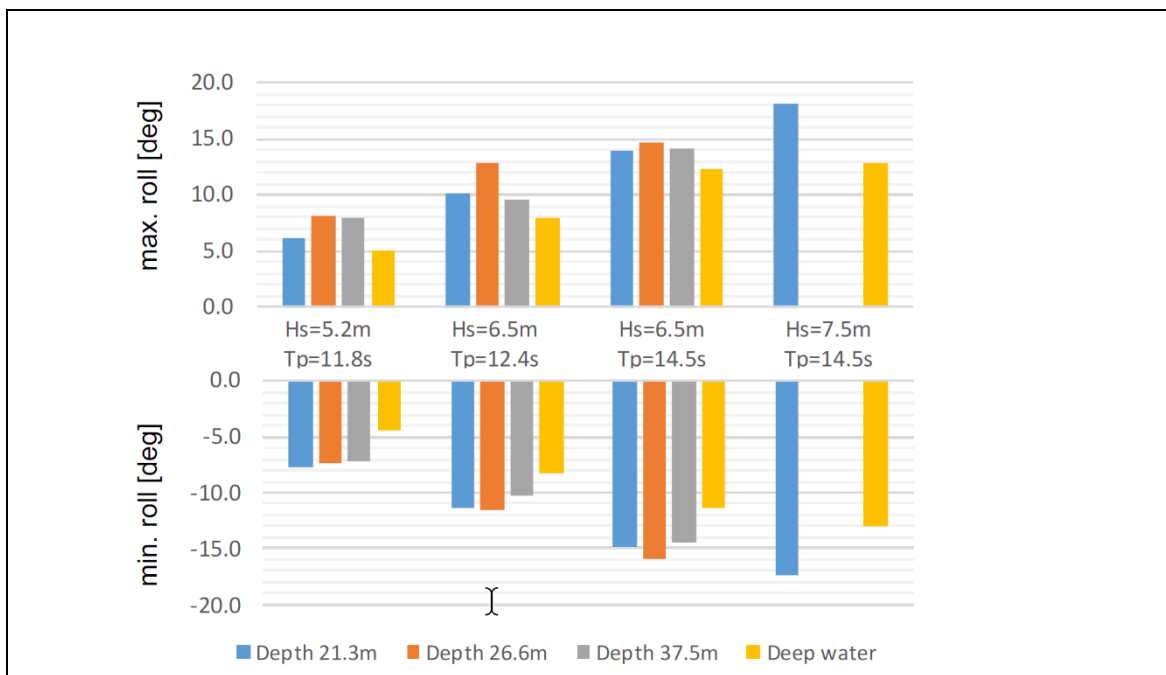
Figure 46: Extreme amplitudes of roll $V_s = 0$ kn, short-crested waves (Source MARIN)
 Note: tests in waves of height 7.5m were only performed for depths 21.3m and deep water.

Similar results for UCLS in general were obtained from the basin tests performed by MARIN. The basin tests were conducted with variations in the significant wave height H_s and wave period T_p . The measured extreme roll amplitudes increase with an increase in H_s and T_p , see figure 46. For a significant wave height of 6.5m and a water depth of 26.6m, the largest roll amplitude measured was around 16°.

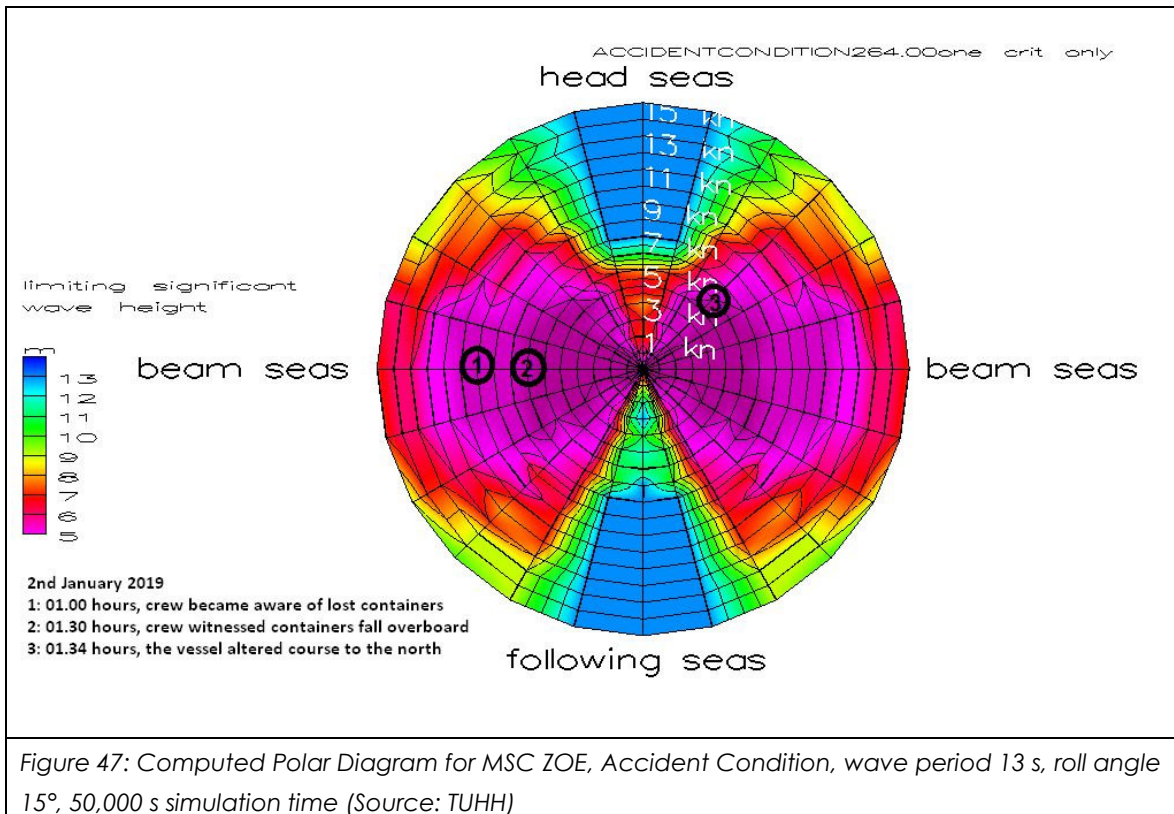
The TUHH calculated the limiting (minimum) significant wave height for a roll amplitude of 15° in waves with a peak period of 13s on different courses, see figure 47. The results show that for the MSC ZOE the beam sea scenario was unfavourable for roll motion under the conditions encountered. The ship is assumed to be in the center of the polar plot. The radial rings represent the ship speed; the sectors indicate the encounter angle of the waves. It can be concluded that a 15° roll amplitude is reached in beam seas in all speeds already for significant wave heights of about 5 m. For all other courses, much larger wave heights are required to reach the 15° roll amplitude. As an example, two moments along the sailing route of the MSC ZOE are presented in the figure (situation 1 and 2 in figure 47). It further shows that also in bow quartering seas, comparable roll angles are possible for wave encounter angles slightly above 30° and slow speed (example situation 3 in figure 47).

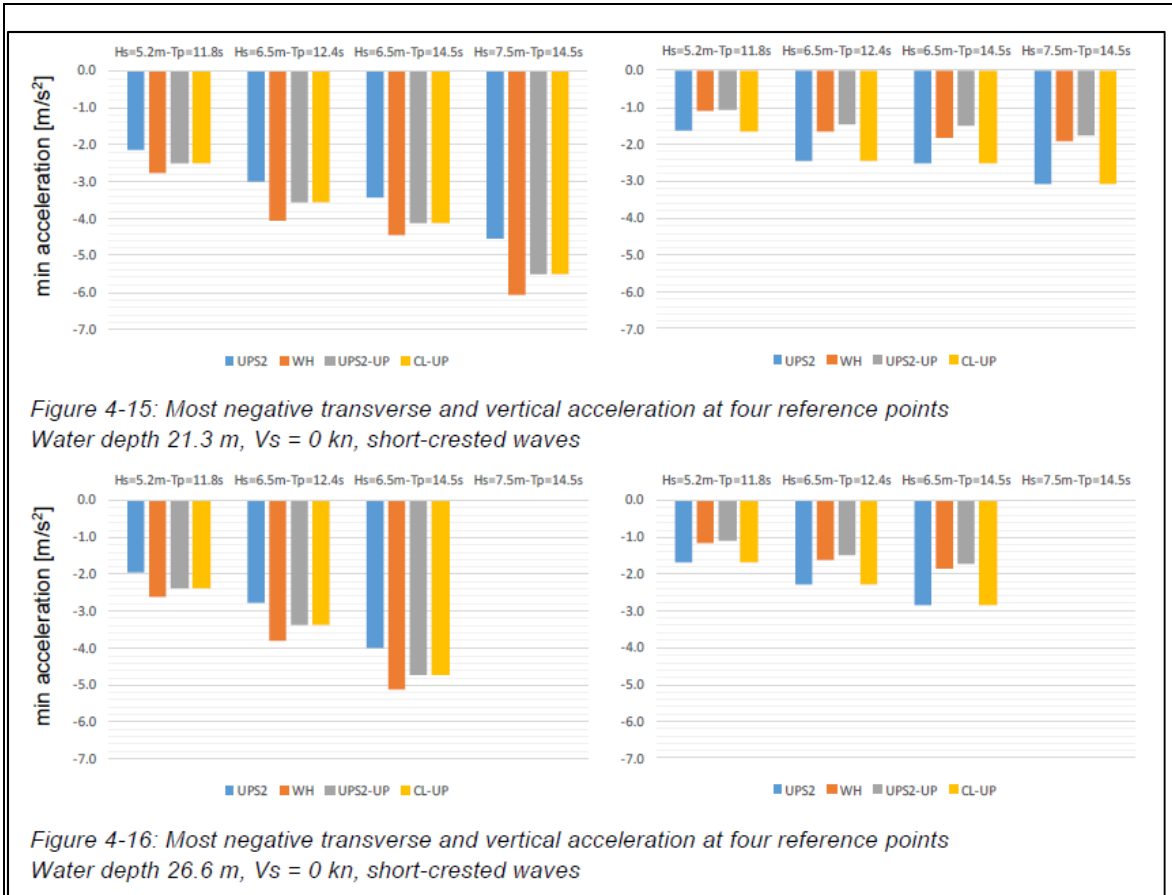
Considering the water depth the MSC ZOE encountered, the MARIN results for water depths of 21.3m and 26.6m are depicted below. The highest transverse accelerations in wave heights up to 6.5 m ($T_p=14.5 \text{ s}$, water depth 26.6 m) reached 4.0 m/s^2 at the lowest

tier of containers on deck, 4.8 m/s² at the top of tier 7 and exceeded 5 m/s² at the wheelhouse, see figure 50. Overall it can be stated that the transversal accelerations increase with the height on deck due to the effect of roll. Accelerations are also found to be larger at a water depth of 26.6m, following the trend of roll (higher maximum roll angle in water depth of 26.6 m compared to 21.3 m).

Figure 50: Most negative transverse and vertical accelerations at four reference points. (Source: MARIN)

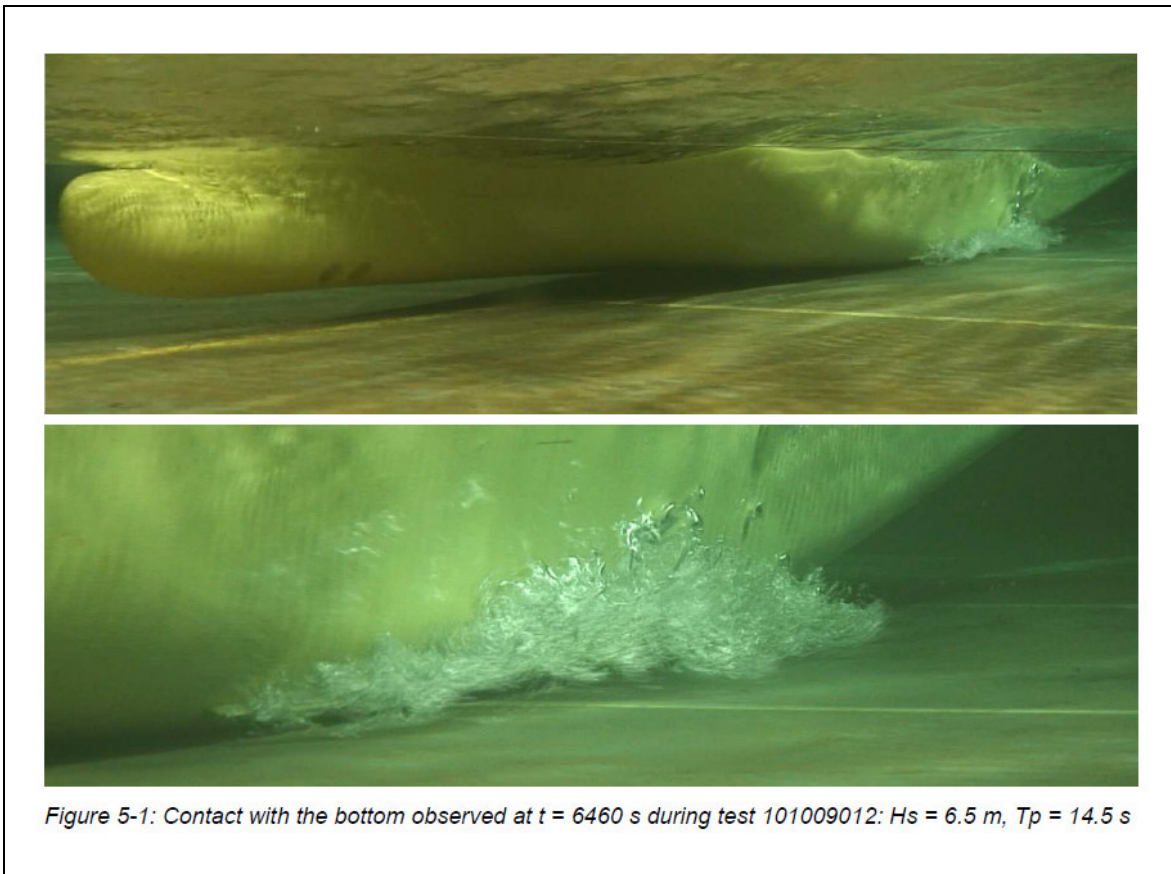
During the tests in the basin, contact or near contact of the model ship with the floor of basin was observed (see figure 51). The frequency of this varied with the wave and ship conditions. During the tests with short-crested waves contact with the basin floor was observed at a water depth of 21.3 m and a wave height of 6.5 meters and above and a peak period of 14.5 meters. The analysis by MARIN of the ship's motions shows that the model can touch the basin bottom when a large vertical heave motion is combined with a large roll motion at the same time in the passage of a group of relatively high waves. The ship also makes a transverse sway motion at that time.

Figure 51: Underwater images of the model ship at the moment of bottom contact (water depth 21,3 meter, $H_s=6.5m$, $T_p=14.5s$, $V_s=0kn$). (Source: MARIN)

Basin tests showed that when a group of relatively high waves passed, the ship model experienced large vertical heave motions with a large roll motion at the same time, resulting in near contact or in some cases contact with the floor of the basin. A contact of the ship with the bottom does not necessarily lead to structural damage. Nevertheless, it will be the cause of vibrations and deformations that will be propagated to the whole structure due to the flexural response of the ship.

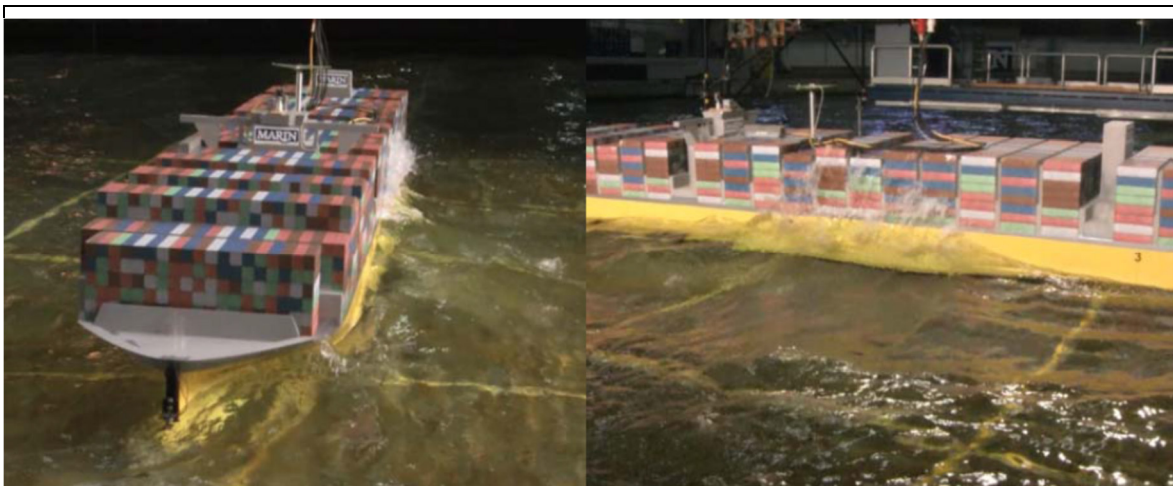
For a container ship, green water has the effect of exerting direct force from the wave on a container. The upwardly directed water can reach above the deck of the ship and can hit the bottom of the lowest containers above the gangway. This can lead to several problems: the bottom containers can be damaged themselves, or containers can be lifted causing damage to the lashings. If one container is damaged or has broken lashings, a whole stack of containers can fall over. The green water can also cause a lateral force on higher-lying containers, so that the container pushes against the container in the next row. This can lead to (part of) a row of containers falling over like a domino.

Figure 52: Images of the ship model and green water effects (source MARIN).

During the basin tests, green water effects were visually observed (using video recordings) for the tested shallow water conditions. Considering the cumulative number of events as observed during the three test conditions, green water was mostly concentrated on six container bays around the wheelhouse (bays 26 to 46). As shown in figure 53, this is in this area where most of the containers on the MSC ZOE were damaged or lost. Although no green water load measurements have been taken in the present tests, this suggests that green water can play a role in the loss of containers in the tested conditions.

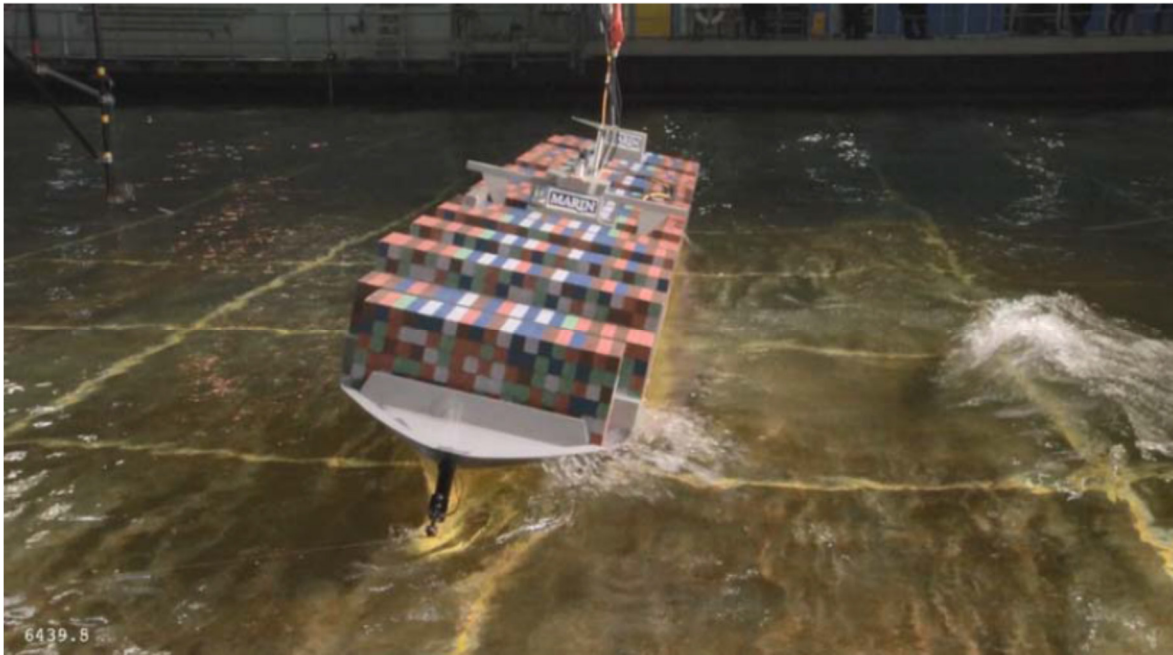
The phenomenon of wave impacts is of the order of magnitude twice as much as green water. The ship model vibrated due to the wave impact. . These vibrations create forces on the frame of the containers and the lashing systems and there is a chance that the lashing systems will break and that containers will fall overboard.

Figure 54: Images of modelship at the moment of slamming (source MARIN)

Slamming was observed in the test for the conditions that were encountered by the MSC ZOE. Impulsive wave loads can result in vibrations in the hull and consequently can create forces in containers and the lashing system.

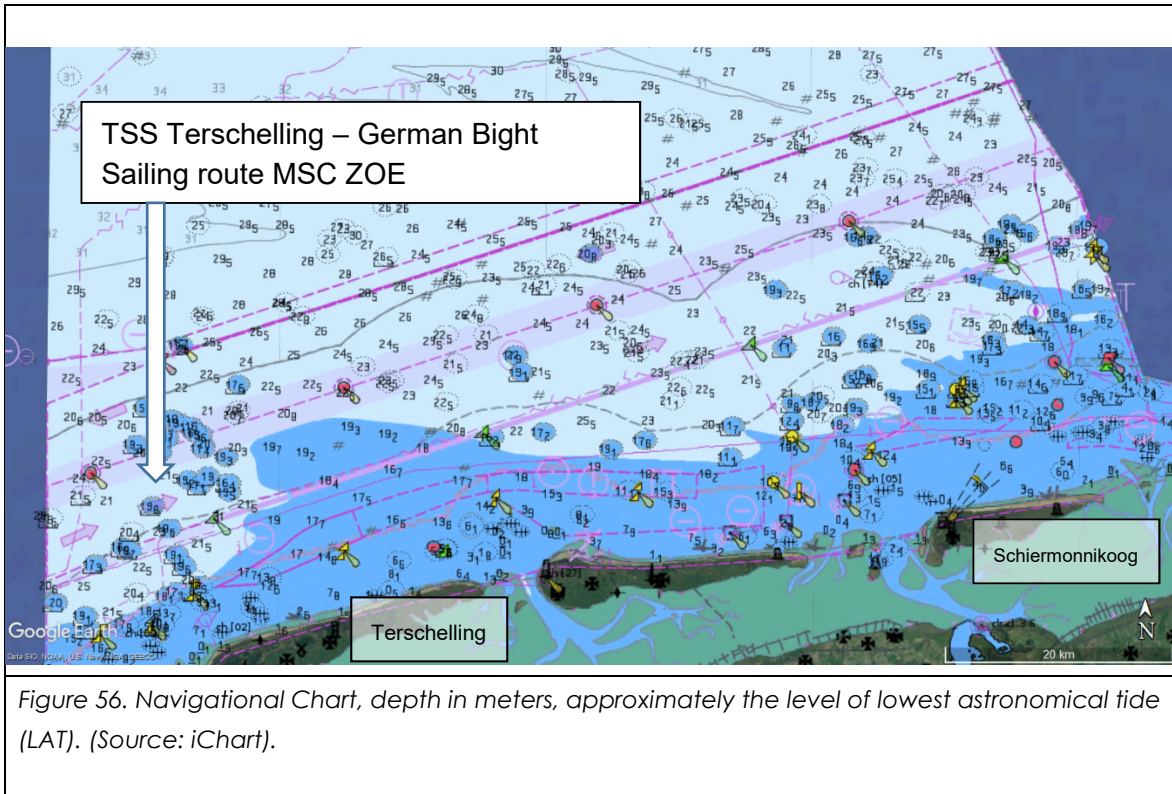
The TSS Terschelling - German Bight has a few shallower areas that are indicated on the navigational charts, see figure 55 below. In order to calculate the remaining Under Keel Clearance (UKC) for the ship, the static draught, water depth, tide, squat and heel angle are to be taken into account. The passage plan of the MSC ZOE for the journey from Sines to Bremerhaven indicates that the ship had a static draught of 12.6 m forward, 12.6 m amid and 12.7 m aft. The passage plan also indicates that at least 4 meter UKC should be kept at all times. A general remark is made on the plan that speed and heel angle may cause an increase of draught.

The chart datum⁶¹ is the water level that depths displayed on a nautical chart are measured from. In the above chart, the shown depths are Lowest Astronomical Tide (LAT) which is defined as the lowest tide level which can be predicted to occur under average meteorological conditions and under any combination of astronomical conditions. Water levels below the LAT can also occur due to weather conditions such as high air pressure or strong winds.
